# Falcon Refinery

aka National Oil Recovery Corporation

- RI/FS Scoping Meeting
  - July 7, 2004

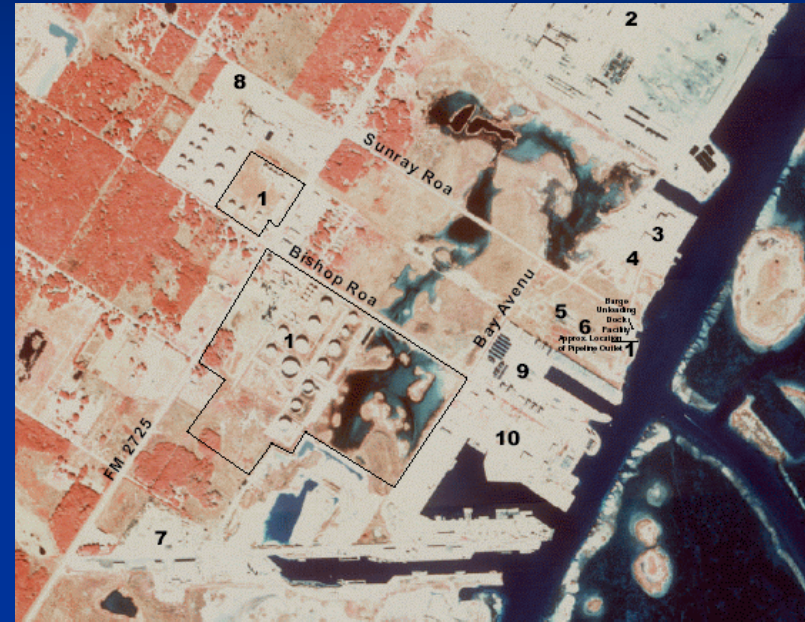
Falcon Refinery aka National Oil Recovery Corporation  
Ingleside, San Patricio County, Texas  
TXD 086 278 058

| 1. Falcon Refinery Site and Dock Facility | 5. IBC Petroleum, Inc. |
| Approximate Boundary | 6. PI Energy Corporation |
| 2. Aker Gulf Marine - Aransas Pass Yard | 7. Garrett Construction Company |
| 3. Offshore Specialty Fabricators<br>(Former Location of Gulf Conservation Corp.) | 8. Plains Marketing |
| 4. Alamo Concrete Products | 9. Brown & Root, Inc. |
| | 10. Ingleside Properties, Inc. |

The base data used is the Port Ingleside NE Digital Orthoquarter Quad (DOQQ), which is a digital version of an aerial photograph. This DOQQ was produced by the TNRC using USGS guidelines. UTM NAD83 Zone 14

- **Plains marketing**, adjacent to the northern portion of the refinery, has had a documented spill, which caused pollution to surface water. They have a docking facility.
- **Garrett Construction**, located south of the site has an abrasive sand blasting operation.
- **Aker Gulf Marine**, fabricator of offshore structures and petroleum related structures, has a TPDES permit.

- **IBC Petroleum and Pi Energy** are located immediately adjacent to the docking facility. Soil samples were taken beneath leaking equipment.
- **Brown and Root**, located near the docking facility, had a leaking UST and soil contamination.
- **Ingleside Properties aka Dugat Docks** is a oilfield waste treatment plant.

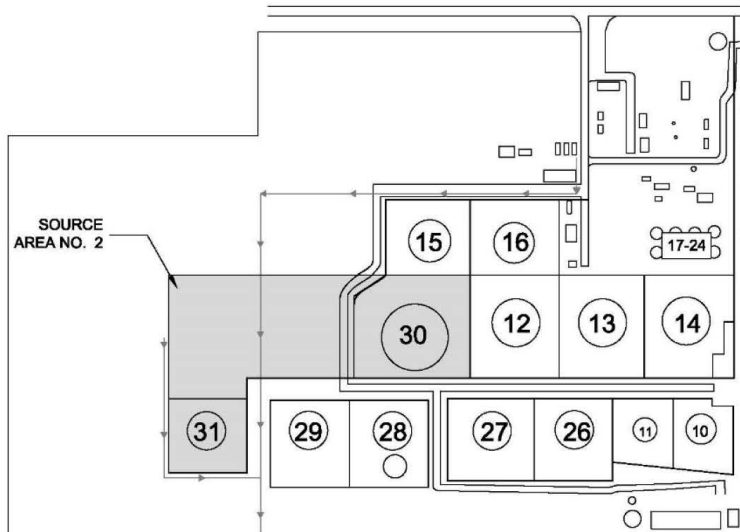
SOURCE  
AREA NO. 2

HAZARDOUS SUBSTANCE	SAMPLE SO-26	TOTAL SOIL COMB. RESIDENTIAL (ALL VALUES mg/Kg)
FLOURANTHENE	0.470	2,300.0
PYRENE	0.490	1,700.0
BENZO(a)ANTHRACENE	0.370	5.70
CHRYSENE	0.580	5.60
BENZO(b)FLOURANTHENE	0.990	5.70
BENZO(k)FLOURANTHENE	0.600	5.00
BENZO(a)PYRENE	0.740	0.56
INDENO(1,2,3-cd)PYRENE	0.560	1,800.0
BENZO(g,h,i)PERYLENE	0.610	1,800.0

NOTE: AN INSPECTION BY THE TEXAS AIR CONTROL BOARD (TACB) ON APRIL 10, 1987 REVEALED A BLACK, LIQUID SUBSTANCE BENEATH A PIPELINE RACK ON THE NORTH SIDE OF THE REFINERY FROM A LEAK IN THE THIRD PIPELINE (10-INCH DIAMETER) FROM BISHOP ROAD (REF. 46, P.9). THE BLACK, THIN LIQUID APPEARED TO BE EITHER A SOLVENT WITH HYDROCARBON/CARBON OR A CRUDE OIL WITH SOLVENTS INTERMIXED. THE PIPELINE CONNECTS THE TANK FARM IN THE REFINERY TO A RUN-OF-PIPE FROM THE DOCKS WHICH WERE USED TO TRANSFER MATERIAL INTO AND OUT OF THE FALCON REFINERY TANK FARM. THE FINAL SPILL COVERED AN AREA APPROXIMATELY 30 FEET BY 60 FEET (REF. 10, P. 7). INVESTIGATIONS APRIL 20 AND 21, 1987 DID NOT INDICATE ANY APPARENT EFFORT TO REMOVE THE SPILLED MATERIAL, WHICH WAS CREATING AN ODOR PROBLEM. ARM REFINING, LOCATED ON THE WEST SIDE OF FM 2725 AND ON THE NORTH SIDE OF BISHOP ROAD, COVERED THE SPILL ON APRIL 22, 1987 (REF. 46, P. 1).

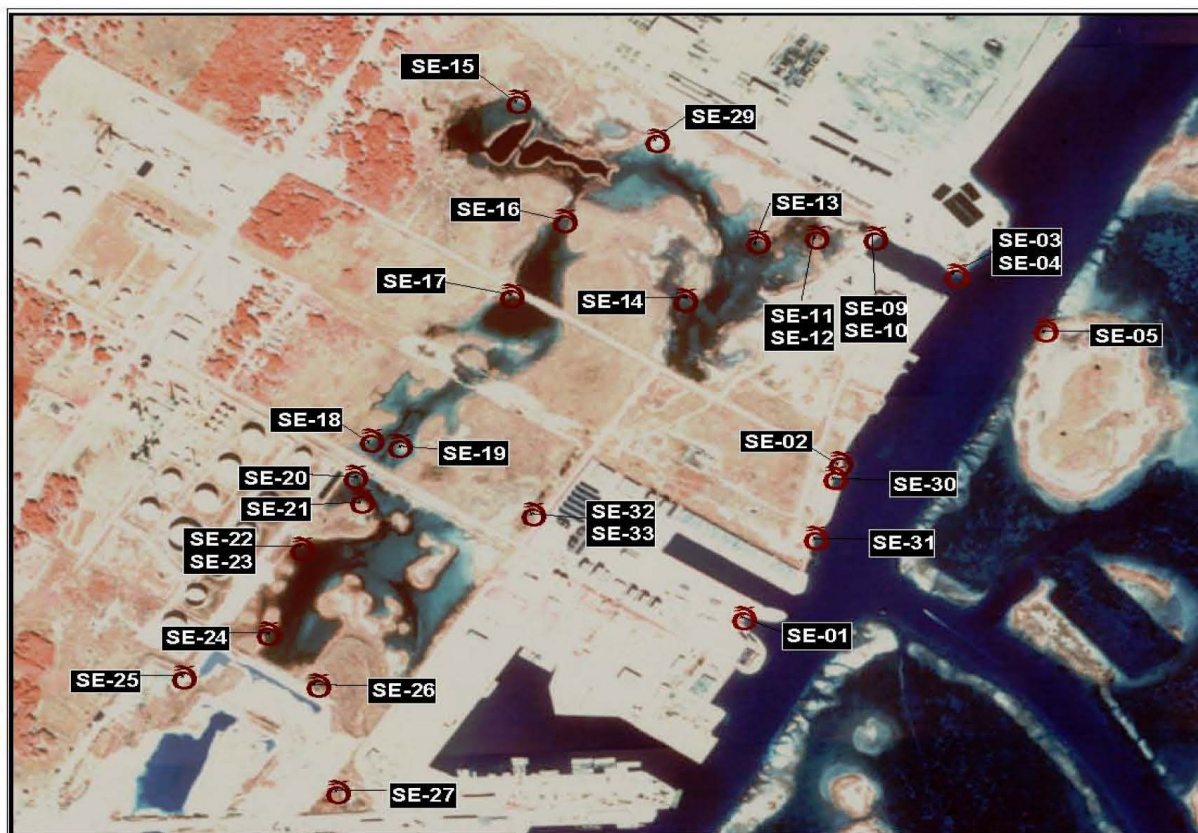
Figure 6  
Surface Water Pathway Overland Flow:  
Sediment Samples

- During May 2000 the TCEQ evaluated the surface water pathway by sampling sediment at 33 locations.
- The locations included four background locations to evaluate observed releases for samples SE-30, SE-31, SE-14, SE-20, SE-21 and SE-27.
- Observed releases are based on detection on compounds above lab method quantitation limit.
